TYWAPPITY COMMUNITY DAM
SCOTT COUNTY, MISSOURI

MISSOURI INVENTORY NO. 40006

PHASE I INSPECTION REPORT
NATIONAL DAM SAFETY PROGRAM

AUGUST 1978

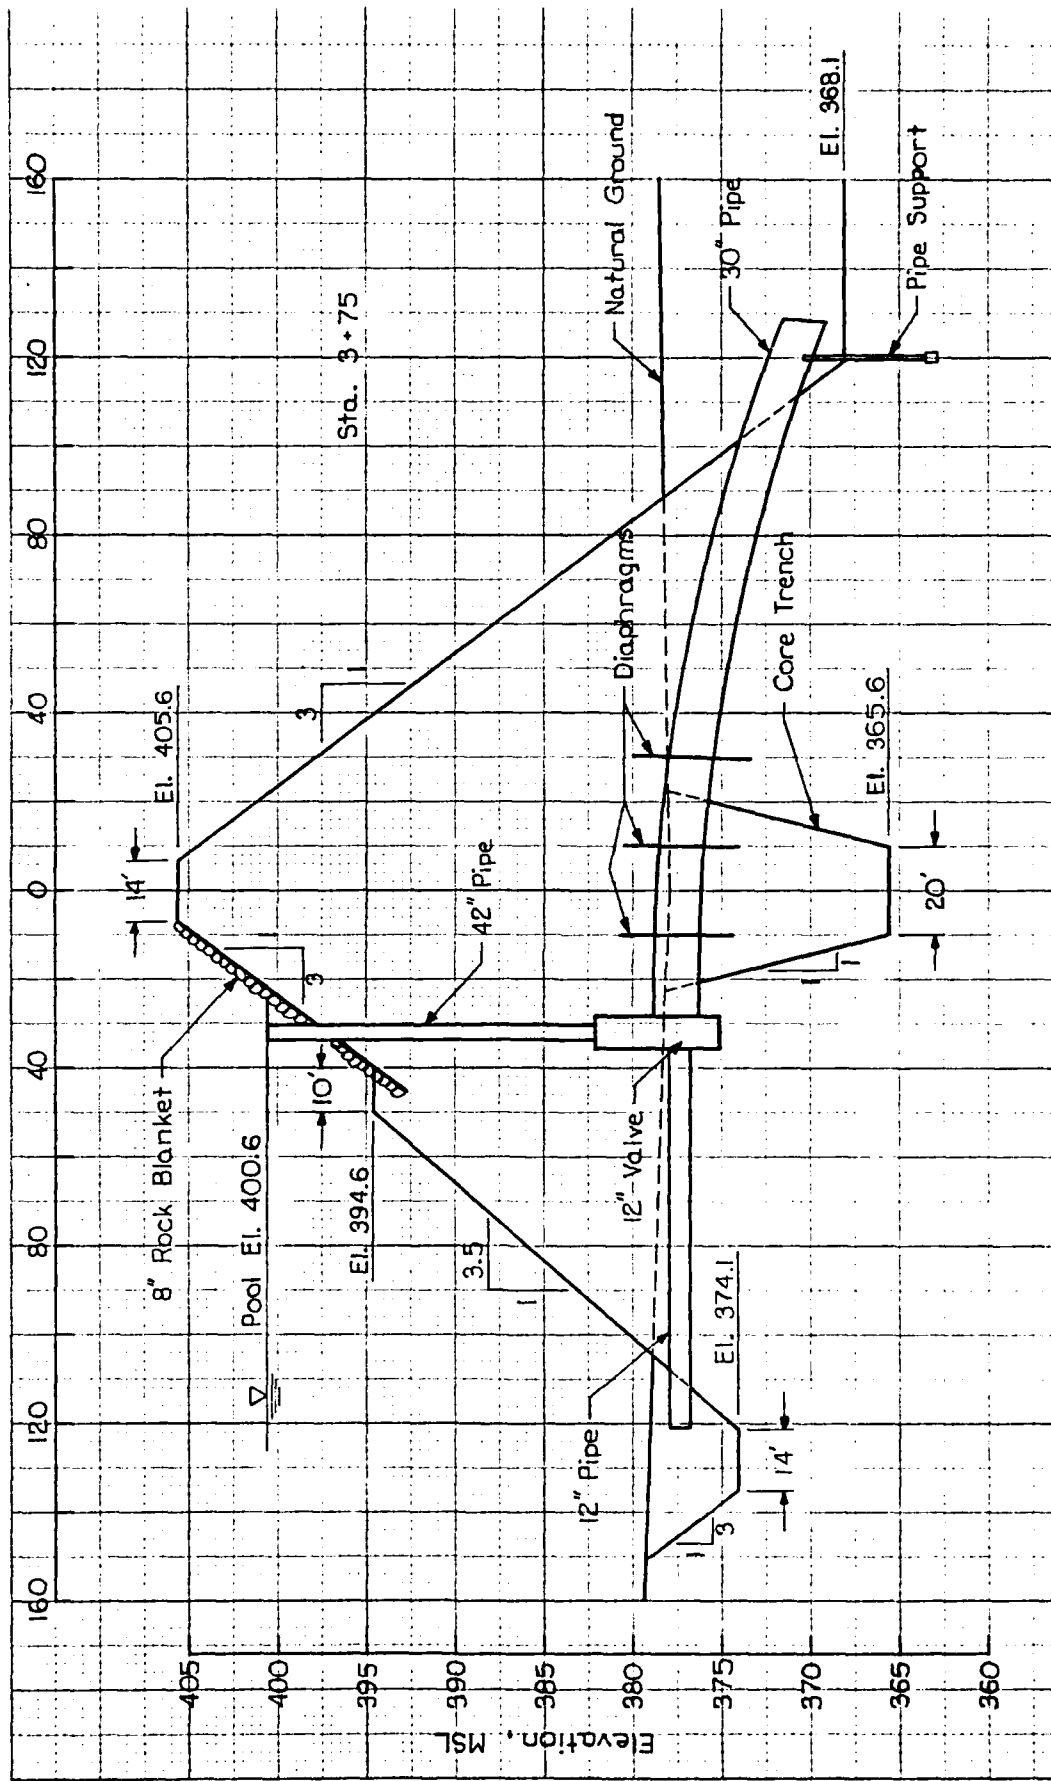
PLATE 4

The stilling basin has scoured to elevation 366.2 m.s.l. approximately 2 feet below the stilling basin elevation specified in the 1956 contract drawings (see Plates 4 and 5). The stilling basin erosion has apparently stabilized.

CROSS-SECTION (STA. 3+75)
1956 CONTRACT DRAWINGS

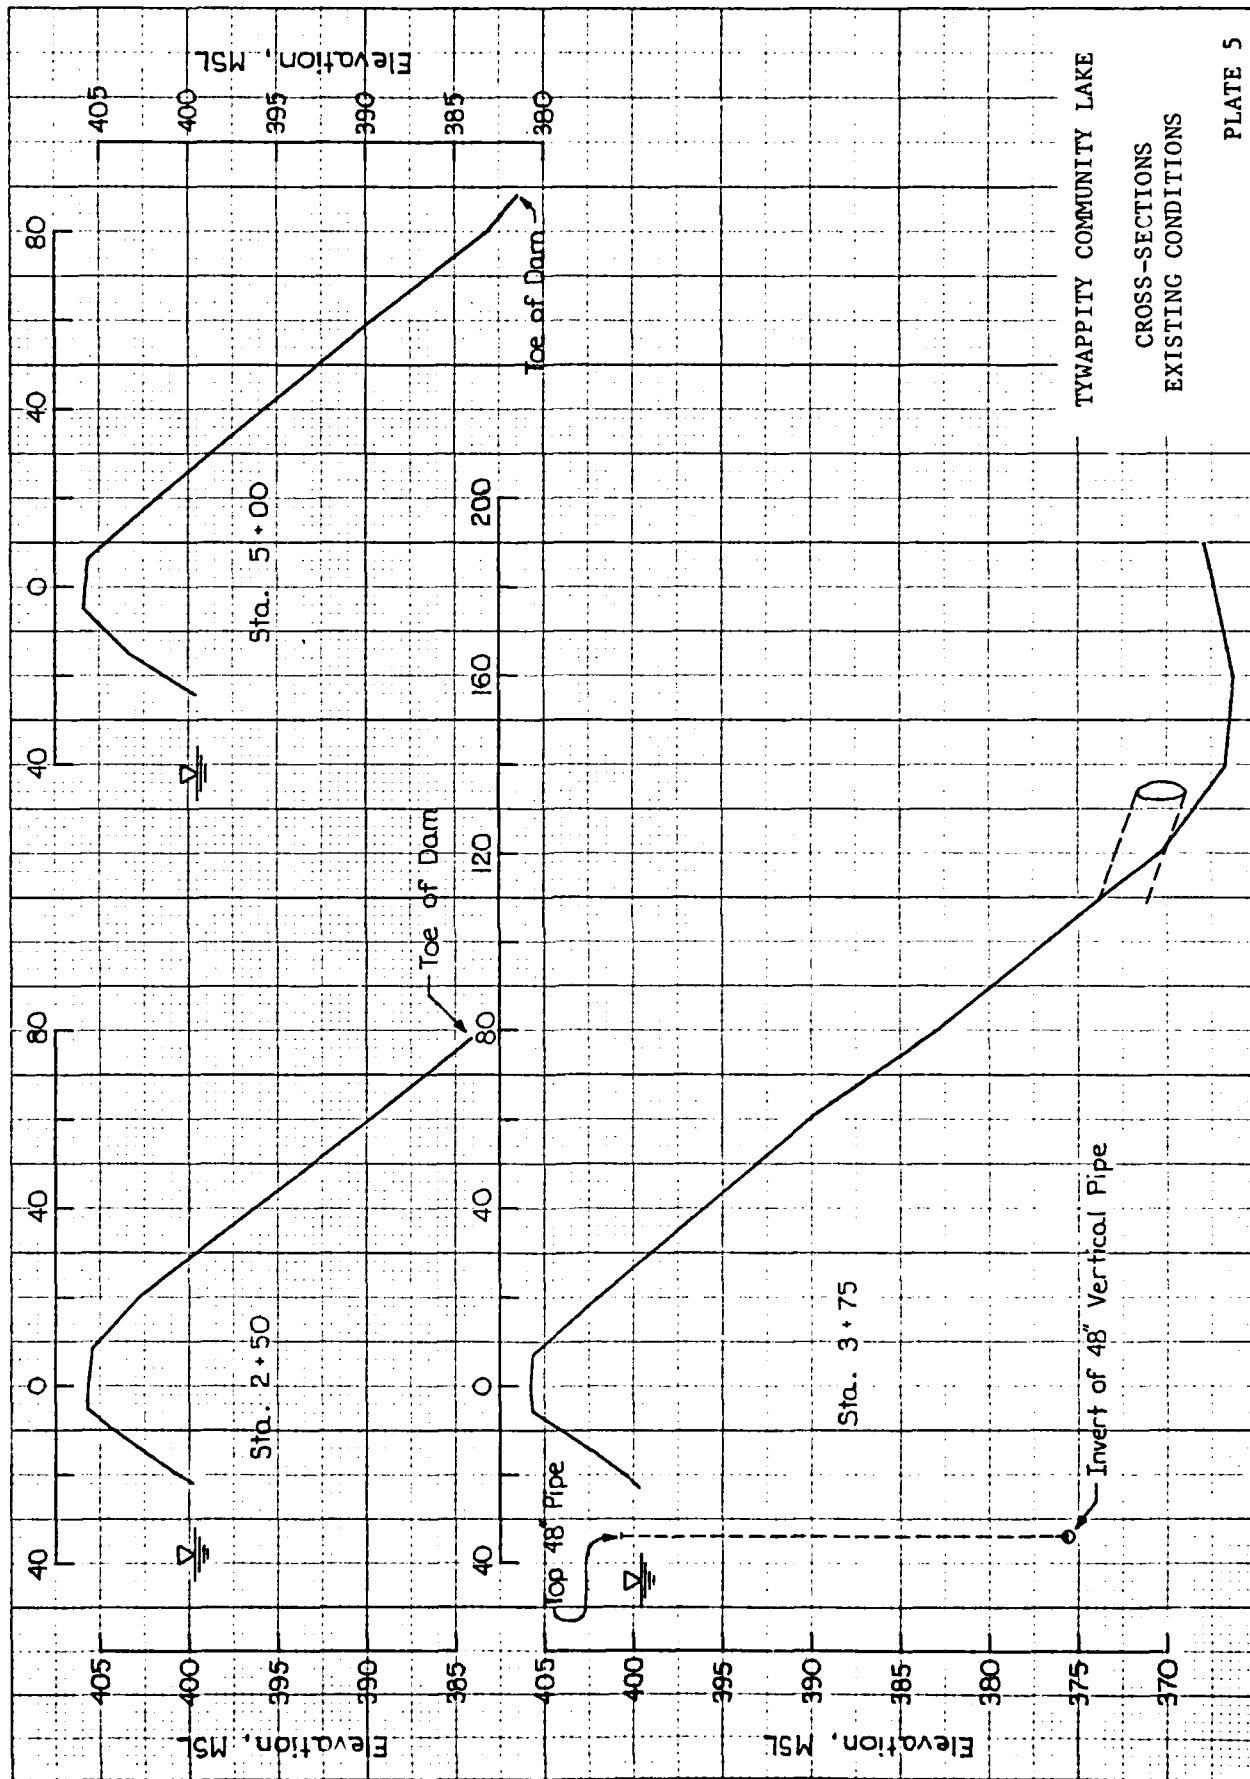
c. Dam. No detrimental settlement, cracking, slides or animal burrows were observed in or near the earth embankment. Typical existing cross-sections of the embankment are shown on Plate 5. These sections are consistent with the cross-sections presented in the Missouri Department of Conservation 1956 contract drawings except the existing downstream slope is a 1V on 3.25H instead of the specified 1V on 3H (see Plate 4 for a typical dam section from the 1956 contract drawings). The dam embankment appears to be well maintained and is clear of bushes and trees except for a few small bushes growing on the upstream slope along the lake edge (see Photo 5). The slopes had recently been mowed and cleared of small brush growth (see Photo 6). The lower portion of the downstream slope had been dressed with a dozer blade (see Photo 7). The upstream slope of the dam is faced with a riprap blanket from the crown to below the lake level (see Photo 4). On the 1956 contract drawings the riprap blanket is specified to be 8 inches thick and to extend from 2 feet below

TYWAPPITY COMMUNITY LAKE
CROSS-SECTIONS
EXISTING CONDITIONS

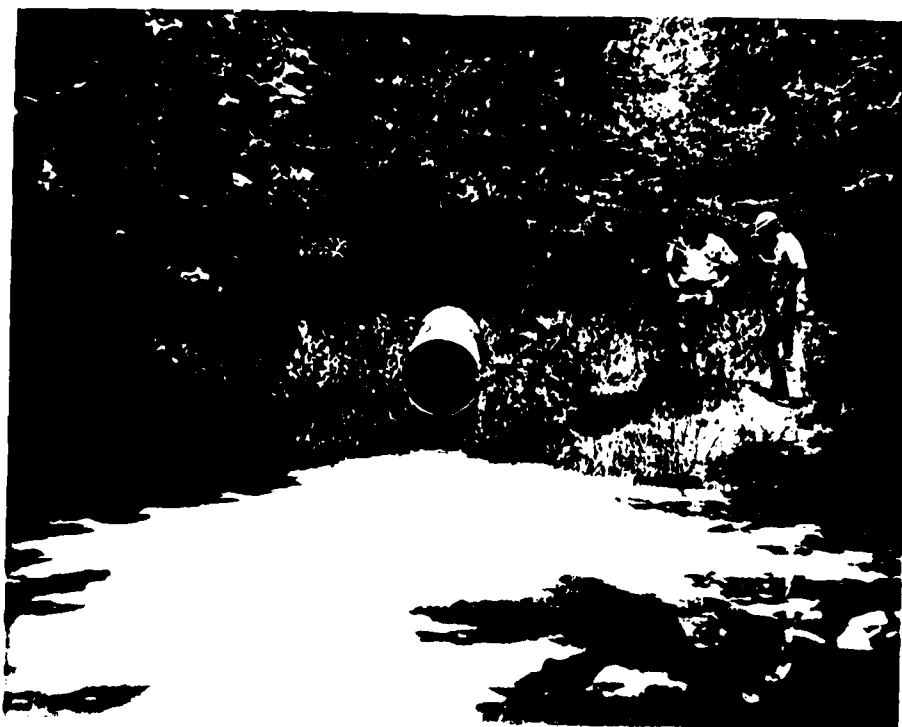
d. Appurtenant Structures. A vertical inlet constructed of 48-inch diameter, bituminous coated, corrugated metal pipe junctioned with a 36-inch diameter, bituminous coated, corrugated metal pipe is the primary means of discharge. A 2.1-foot by 7.5-foot corrugated metal baffle is mounted on the vertical inlet. A trash rack composed of timber posts and strands of barbed wire surrounds the inlet (see Photo 8). The outlet pipe discharges into an earth stilling basin located approximately 134 feet downstream of the dam center line (see Plate 5 and Photo 9).

PHOTO 9: Discharge of Vertical Structure

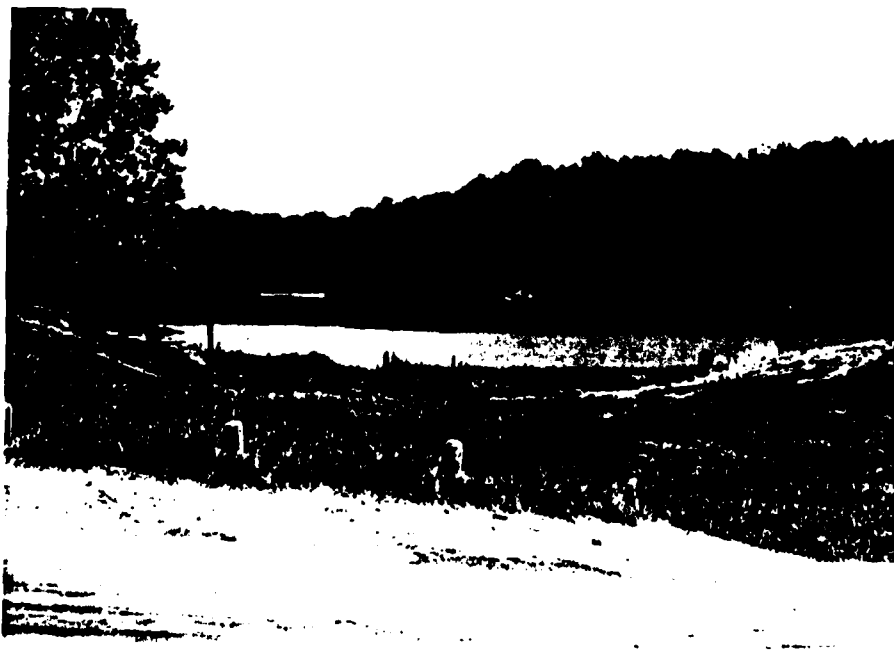
A grass covered, earth, emergency spillway is cut in the right abutment. The spillway is a trapezoidal section with a 50-foot bottom width and side slopes of 1V on 3H. The spillway is 125 feet long and is intersected at right angles by a 20-foot wide asphalt road. No erosion was observed in the emergency spillway area (see Photo 10).

PHOTO 10: Emergency Spillway
